# Legionnaires' Disease Outbreak on a Merchant Vessel, Indian Ocean, Australia, 2015

Two cases of Legionnaires' disease and 1 of Pontiac fever occurred among the crew of a merchant ship operating off the shores of Australia. PCR assays identified potential sources in the ship's cabins. Modification of maritime regulations for Legionnaires' disease prevention in commercial vessels is needed for nonpassenger merchant ships.

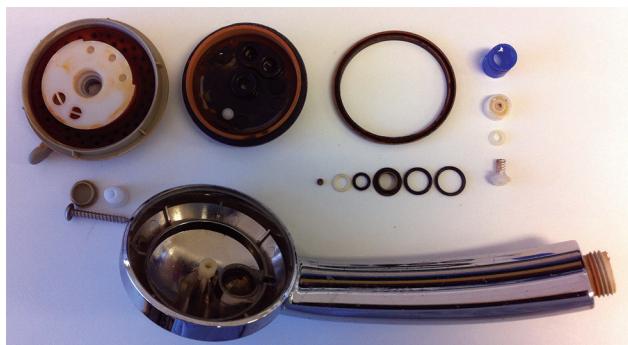
**Figure 1.** Dismantled showerhead from nonpassenger merchant vessel showing multiple inner parts, including 7 O-rings, all of which were in contact with water passing through shower, Australia, 2015.

infection. All showerheads on the vessel had interior moving parts to control spray settings and were the leading PCR-positive location. A rust-colored biofilm inside most showerheads indicated possible deterioration of iron pipes in the ship's distribution system, and persistence of *Legionella* in biofilms (15). The silicone rubber O-rings from the showerheads supported profuse growth of aquatic bacteria and were PCR positive for *L. pneumophila*. The O-rings formed a permanently wet niche for bacterial growth, and their movement will shear bacteria from biofilms. Faucet aerators also promote turbulent flow by mixing water and air under pressure. These results highlight the potential for *Legionella* aerosol generation. We recommended replacing the showerheads with a simpler plastic design, more suited to periodic removal, decontamination, and cleaning, and gravity drainage after daily use.

Showerheads removed from cabins at the time of the initial environmental investigation were sent to the public health laboratory for additional analysis. The inside surface of the showerhead its O rings were tested by PCR assay.

After dismantling showerheads and collecting PCR swab specimens from the inside surface of the shower rose and any O-rings found, the O-rings were dabbed onto *Legionella* selective media (BCYE) and chocolate agar, the plates incubated and bacterial growth identified by matrix-assisted laser desorption/ionization-time of flight mass spectrometry and conventional bacteriological methods. The showerhead parts were rinsed with sterile 0.08% NaCl solution and the washings used to recover *Legionella* species and free-living amoebae.

Reference laboratory PCR assays for *L. pneumophila* produced unambiguous positives in 13/16 showerheads (19/32 samples). Almost all O-rings from the common shower types were *L. pneumophila* positive.
