Transmission of SARS-CoV-2 through Floors and Walls of Quarantine Hotel, Taiwan, 2021

We investigated a cluster of SARS-CoV-2 infections in a guarantine hotel in Taiwan in December 2021. The cluster involved 3 case patients who lived in nonadjacent rooms on different floors. They had no direct contact during their stay. By direct exploration of the space above the room ceilings, we found residual tunnels, wall defects, and truncated pipes between their rooms. We conducted a simplified tracer-gas experiment to assess the interconnection between rooms. Aerosol transmission through structural defects in floors and walls in this poorly ventilated hotel was the most likely route of virus transmission. This event demonstrates the high transmissibility of Omicron variants, even across rooms and floors, through structural defects. Our findings emphasize the importance of ventilation and integrity of building structure in quarantine facilities.

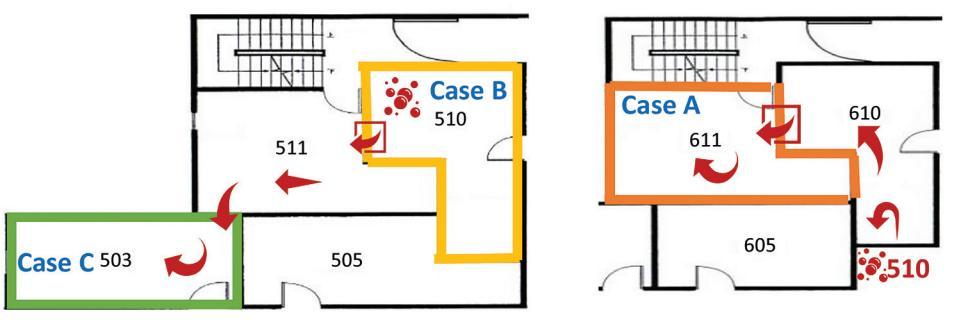
Figure 3. Simulation of probable air flow (arrows), implicating how virus-laden aerosol transported from the room of the primary case to the rooms of secondary cases in a quarantine hotel in Taipei City, Taiwan, December 2021. The bubbles symbol indicates the location of the source of transmission.

🗱 Source of virus-laden aerosol

- Probable flow of virus-laden aerosol
- Location of residual tunnel between rooms 10 and 11

Room 611 (case A) and room 503 (case C) are not directly adjacent to room 510 (case B). We found truncated pipes above the ceiling in the room 510 bathroom, which might have connected to room 610, and a residual tunnel above the ceiling that might connect room 610 to room 611 (case A). A residual tunnel in

the same location was also found in the middle of room 510 (case B) and room 511, and another tunnel connected room 511 and room 503 (case C). Because the air conditioners in each room are constantly pushing the air, the airflow carries the virus-laden aerosol. This aerosol might penetrate wall defects or go through old tunnels to reach other rooms (Figure 3), even nonadjacent rooms that appear to be independently isolated. When exhaust fans are not running at the same time (persons usually turn them on only when using the bathroom), it can result in pressure differences between rooms.

In addition to the obvious structural defects we discovered, tiny cracks in walls and ceilings also might have enabled air flow between rooms. To confirm that the wall defects and pipes interconnected the air in each room, we conducted a simplified tracer-gas experiment using methods similar to those used widely by petrochemical and automotive industries. The tracer-gas is released in small quantities into the main body of air to determine if leakage exists in a ventilation system. Previous studies used similar methods to simulate the process of potential transmission through air in 2 communities in China (31,32). Although those researchers chose sulfur hexafluoride, chloroform, and carbon tetrachloride as tracers, we chose ethanol as an index tracer because it is a detectable TVOC that is not harmful to humans and is easily obtained. Our goal was to demonstrate that 2 seemingly independent, closed rooms had hidden interconnections. Because of the lack of background TVOC measurements in rooms 503 and 505, the results were insufficient for comparison. However, we were able to deduce that the recirculated air transported through room 510 (case B) to room 503 (case C) based on observations in room 510 (case B) and room 611 (case A) during the experiment.
